Case Report

Missed foreign body falsely interpreted as glass in surgery

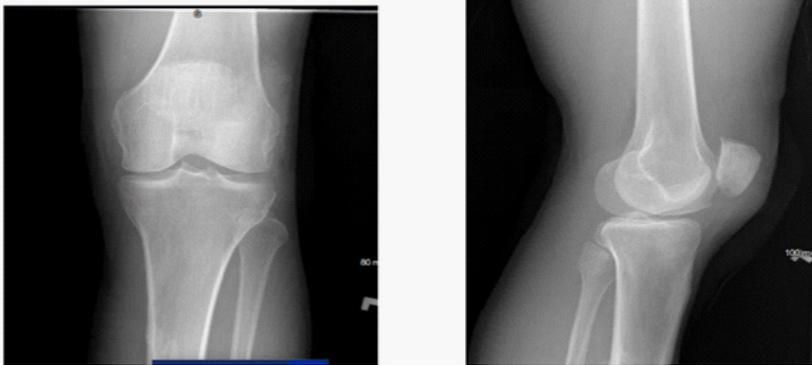
X-ray left knee

Figure 1: AP and lateral plain radiograph of the left knee.

Conventional x-rays were ordered of the femur, knee, tibia, and fibula, all revealing no acute osseous abnormality (Figure 1). Specifically, the CT knee demonstrated “no acute fracture or dislocation. No osseous erosive process. No significant knee effusion. Small amount of soft tissue air, likely due to injury in the prepatellar soft tissues, correlate clinically. Small hyperdensity is seen anterior to the patella likely due to small hematoma measuring 1 cm x 0.5 cm with prepatellar soft tissue swelling” (Figure 2).

Based on the case presented above, the FB was missed on plain film (Figure 1) and recognized on the CT scan (Figure 2) but dictated as a small hematoma. This is a common theme; a study done in vitro demonstrated that no reader could visualize plastic on x-ray, but could identify glass and metal [5]. This finding was further corroborated by [6] using their pig phantom model, 2 out of 5 (different types of plastic) were visible on conventional x-rays. The reason is that radio-opacity is related to atomic number. Plastic is made of hydrogen, carbon, oxygen, and fluorine; depending on the composition, the atomic number ranges from 5.44-8.43 [7]. Soft tissue has an atomic number of roughly 7.5; because the difference between the atomic numbers is negligible, there is no contrast between the mediums, which makes neither medium differentiated from the other in plain radiography [8]. In contrast, the atomic number of metal is significantly greater than that of soft tissue; it is radiopaque and is clearly differentiated from soft tissue.

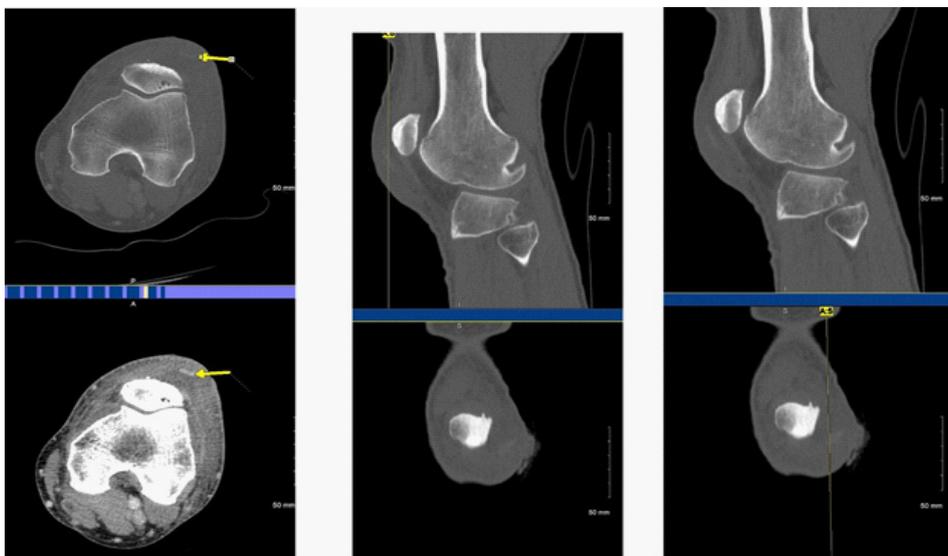
Figure 2: Axial, sagittal and coronal non contrast CT of the left knee, the yellow arrow denotes what was originally dictated as a “small hematoma measuring 1 cm x 0.5 cm with prepatellar swelling”. The arrow represents the FB.

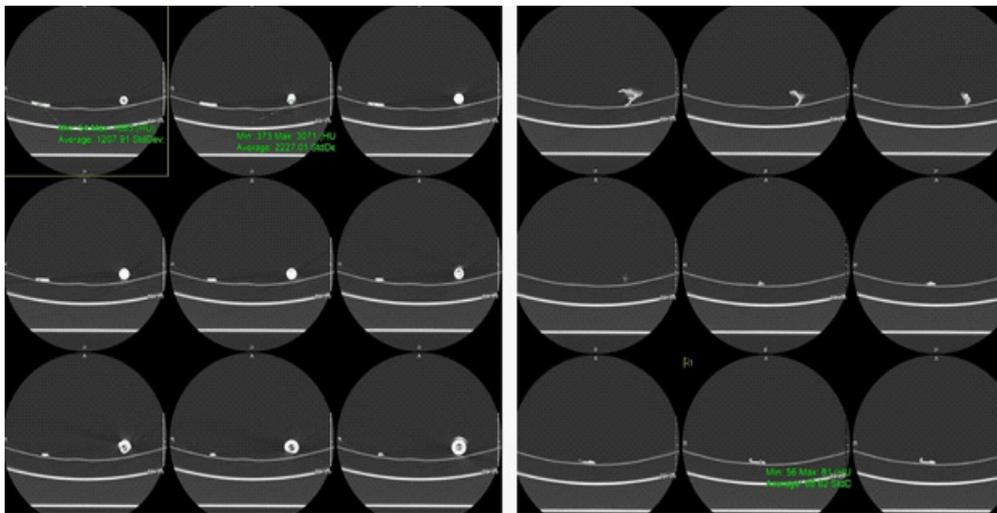
Figure 3: Phantom CT of glass (HU 1207.91), metal (HU 2227), and plastic (HU 88.62) from a broken taillight imaged in the same CT scanner the as the patient was imaged in.

*Plastic had lots of variety of HU in the literature ranging from -100 to 500 [5,6,2]. The values of 10-100 were chosen because it most closely encapsulates the most common values seen in the literature [5]. Had plastic attenuating at 73 HU which resembled the CT scanner at the hospital it was imaged on.

studies (Table 1). Plastic from an automobile light in the CT scanner at our medical center had a HU of 88.62 (Figure 3), and the study was dictated as a hematoma. A hematoma usually has a HU of 40-60 (Table 1); depending on the onset (acute or chronic), the HU can range from 28-82 [9] because of the difference in calcium and iron based on the time. Identifying that car taillight plastic averagely attenuates at 88.62 HU at our institution highlights an area of improvement that hematoma should not have been suggested. The purpose of this case is to prevent further deleterious events from happening in the future. Based on the medical record, a piece of glass was pulled out of the surgical wound, this is not probable because glass has substantially higher attenuation than plastic on CT (Table 1). In addition, if the FB was glass, it would have likely been easily identifiable on x-ray due to the radio-opacity of glass.
